# Manhole Inspection Summary

Manhole # S31E\_\_024MH

Insp Date: **12/15/08 2:38 PM**

**Location** Address: **unknown alley**

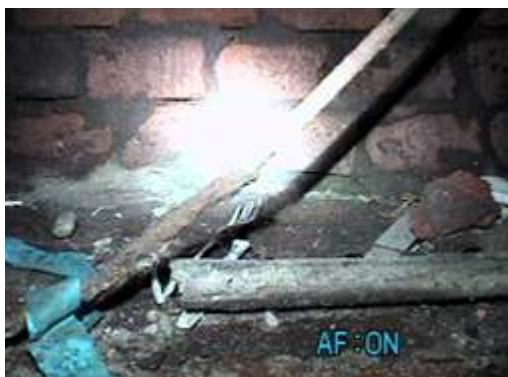
Miscellaneous

channel debris

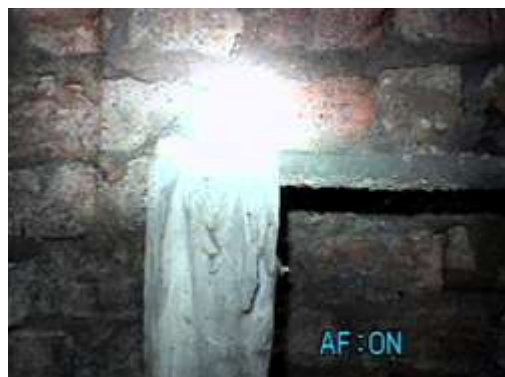
Defect 5

**Surcharge** ☒ **Evidence Of Surcharge** Depth: **4** (ft.) ☐ Active Surcharge Present

evidence of surcharge

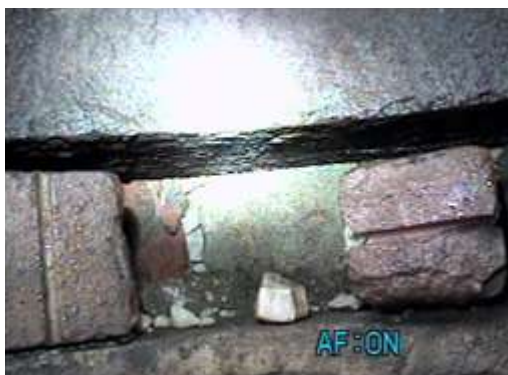
Defect 3

Condition: ☐ Sound ☒ **Cracked** ☐ Root Intrusion ☒ **Loose Brick** ☒ **Deteriorated**

chimney cracked loose bricks,  
deteriorated

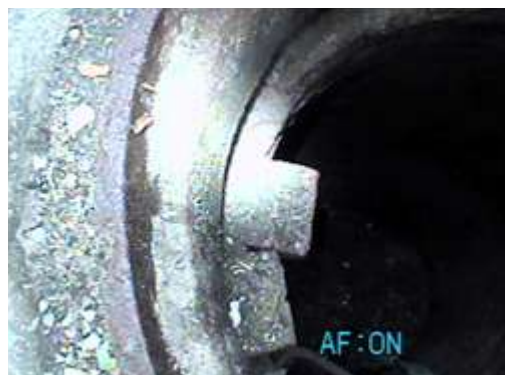
Defect 2

**Frame** Offset: **4** (in.) Condition: ☒ Sound ☐ Cracked ☐ Leaks

frame offset 4 inches

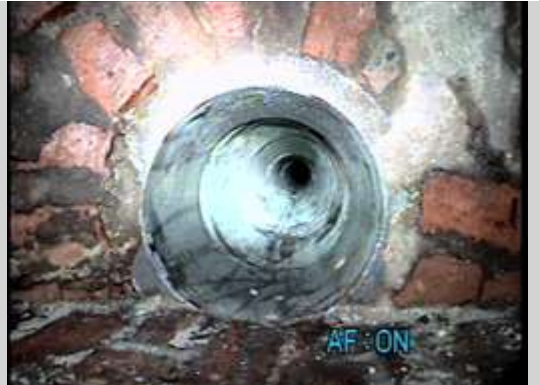
12 O'Clock Outflow

8 in. Circular Gravity Sewer  
Pipe Out @ 12 O'Clock
